HERITAGE CONSERVATION: FROM TRADITIONAL TO CONTEMPORARY HERITAGE USING ONE ANALYTICAL METHOD

Stephen J. Kelley, editor

ASTM publication, 1996

Heritage Conservation: From Traditional to Contemporary Heritage Using One Analytical Method

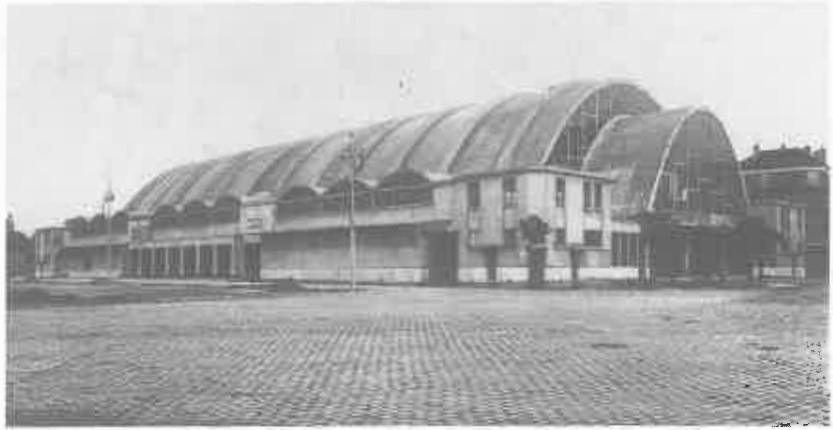
FIG. 9—*Reims Marketplace—Exterior of north elevation, 1928* [17].

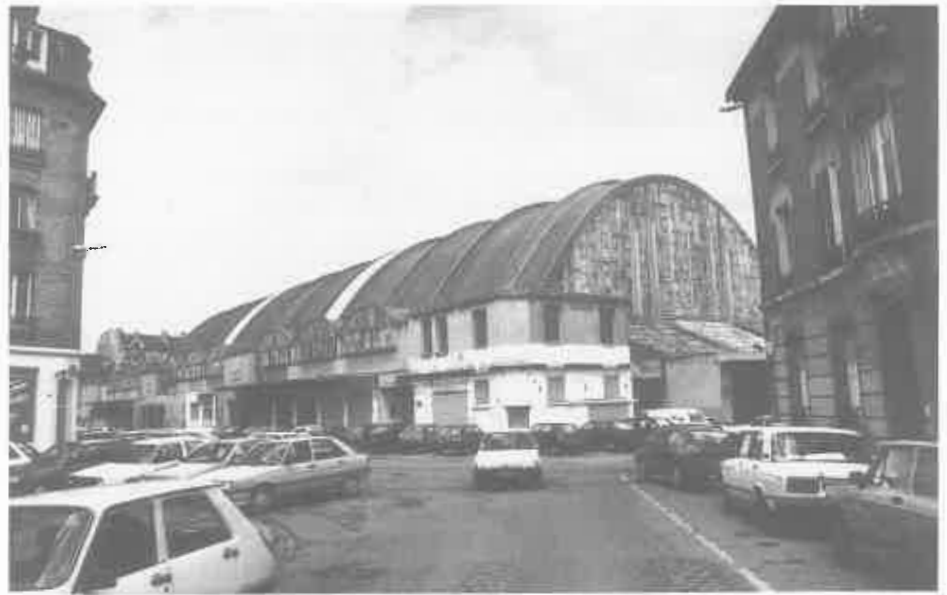
FIG. 10—*Reims Marketplace—Exterior existing condition, 1992* [9].

The Reims Central Marketplace was built in 1927 of reinforced concrete using a process developed by the engineer Eugene Freyssinet (Fig. 7). The original architectural design was completely transformed by applying Freyssinet's engineered solution of thin-shell concrete (Fig. 8). The building is really at a crossroads between engineered practicality and architectural expression (Fig. 9). These shell vaults with a parabolic profile now show signs of serious deterioration, making it necessary to close the building and discontinue its use (Figs. 10 and 11).

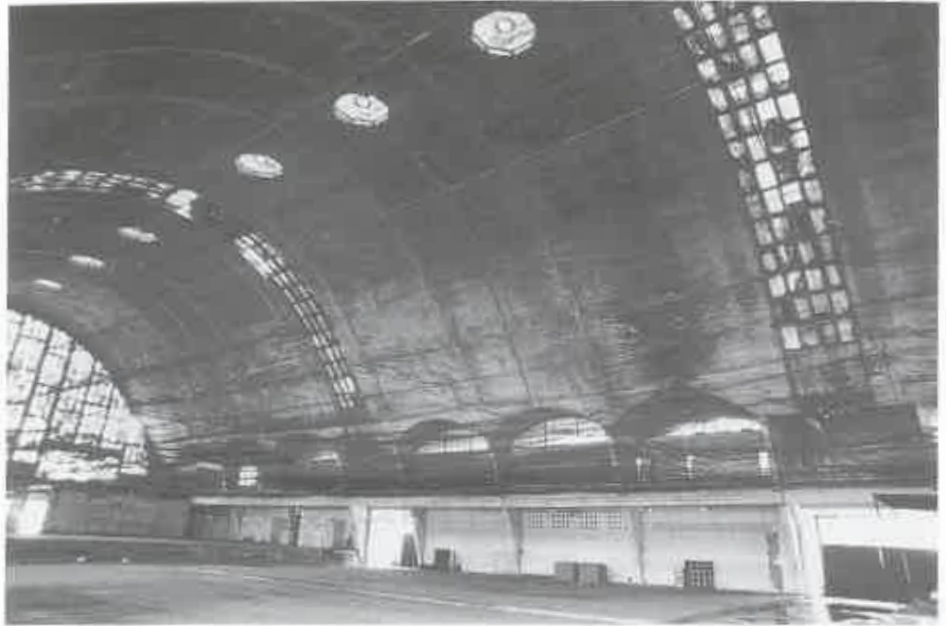
FIG. 11—Reims Marketplace—Interior existing condition, 1992 [9].
